# Broomfield House: condition survey of the Lanscroon wall painting fragments ~ August 2014

#### 1 Introduction and summary of the report

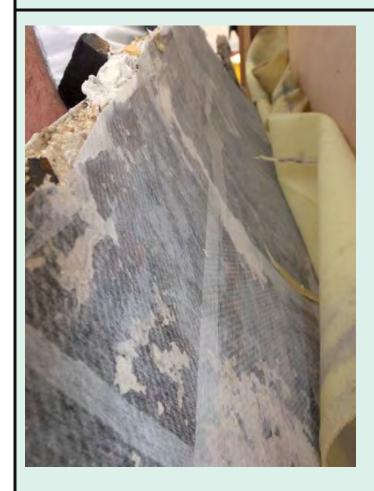
One large fragment (148cm x 60cm) which shows the original structure of the paintings- lath and plaster covered with a coarse hair plaster and then a fine finishing topcoat of plaster. There are some plaster of Paris repairs and the fragment has been faced. There has clearly been extensive loss of the paint layer.

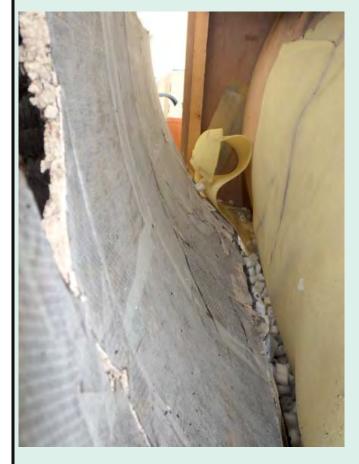
One large fragment (134cm x 62cm) which shows the original structure of the paintings- lath and plaster covered with a coarse hair plaster and then a fine finishing topcoat of plaster. There are some plaster of Paris repairs and the fragment has been faced. There is extensive charring of the timber support.

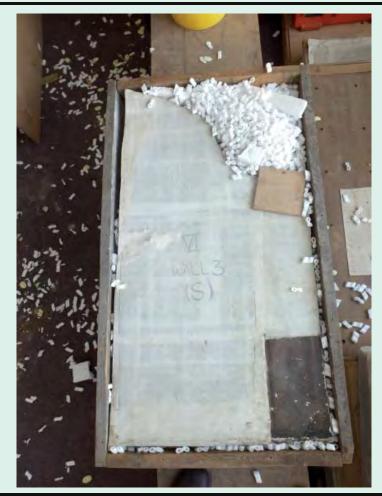
One large fragment (114cm x 63cm). The fragment has been faced with tissue and gauze. One area of facing has been removed to reveal the paint layer which is in good condition.

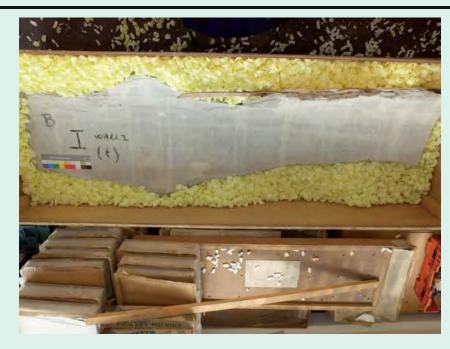
One fragment (67cm x 40cm). Multiple layers of facing with some plaster of Paris repairs.

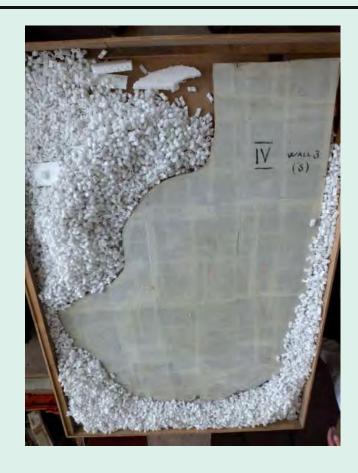
Dimensions 1126cm x 176cm. Fragment heavily faced so the paint layer is not visible.

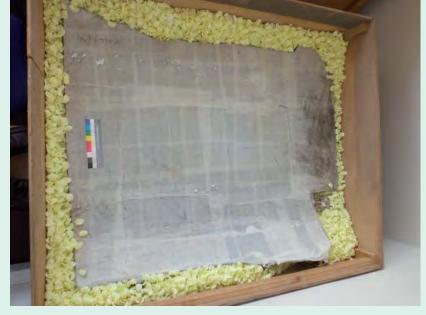
Large fragment (150cm x 105cm), faced with gauze. Previous plaster of Paris repairs visible beneath the gauze following a crack where the painting is distorted.

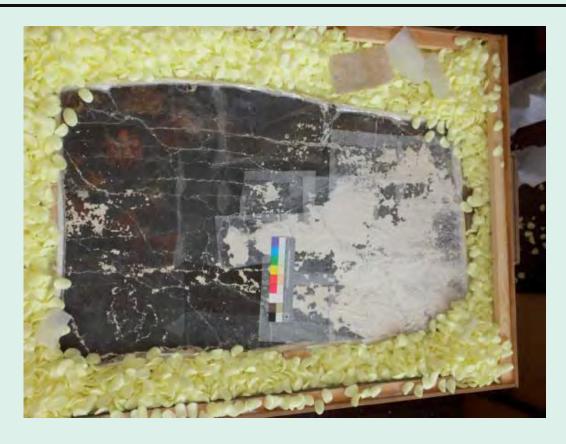
Large fragment (30x50). Fragment faced. Extensive loss of paint layer.

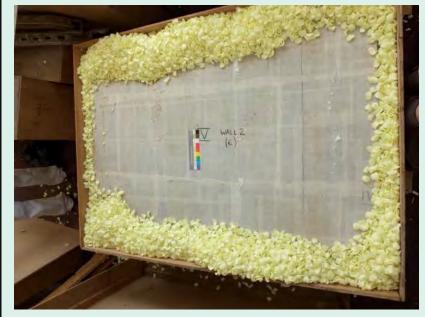
Large fragment (160x90). Fragment faced and paint layer appears to be complete. Lath and timber support is very charred.

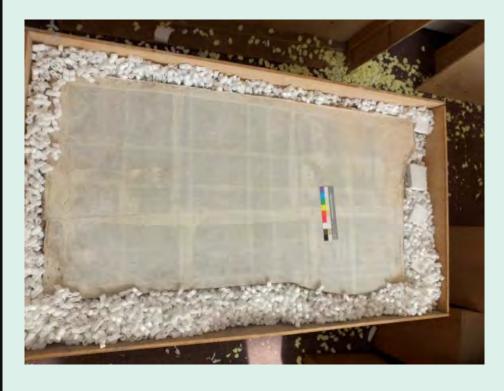
Large fragment (70x130cm). Fragment faced and paint layer appears to be complete although some losses are evident. Lath and timber support is very charred.

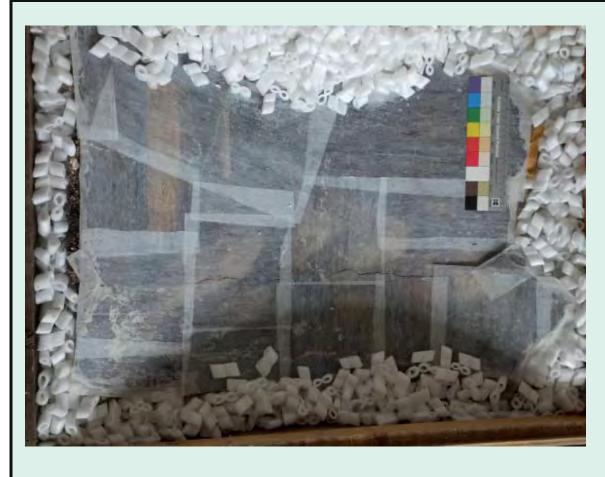
Large fragment. Faced with tissue. Extensive remains of paint layer evident.

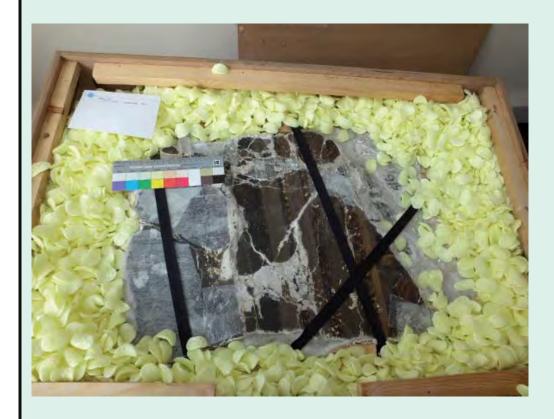
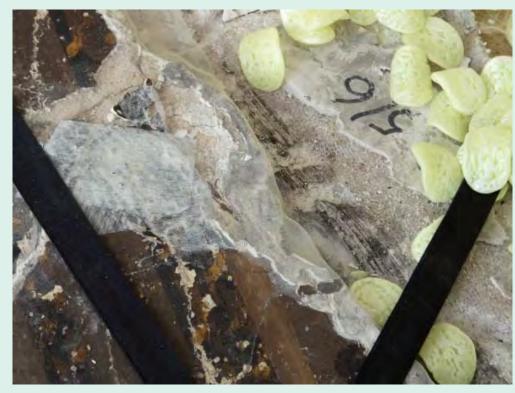
Dimensions: 45 x 110cm approx. Condition of the fragment is poor with some loss of paint layer and evidence of previous repairs. Partially faced. Location not identified.

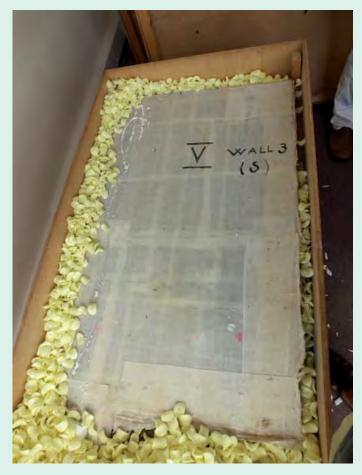
Fragment heavily faced with gauze. Difficult to ascertain condition but the paint layer appears intact below with some loss/repair.

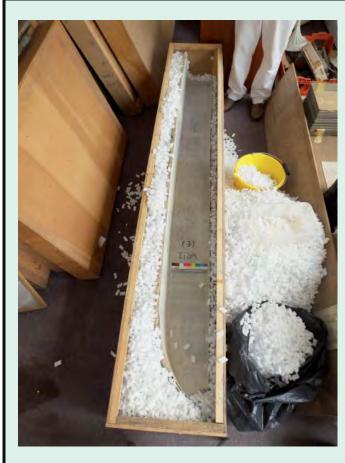
Dimensions 250mm x20 x20: Fragment heavily faced with gauze. Difficult to ascertain condition but the paint layer appears intact below with some loss/repair. One area clearly fractured.

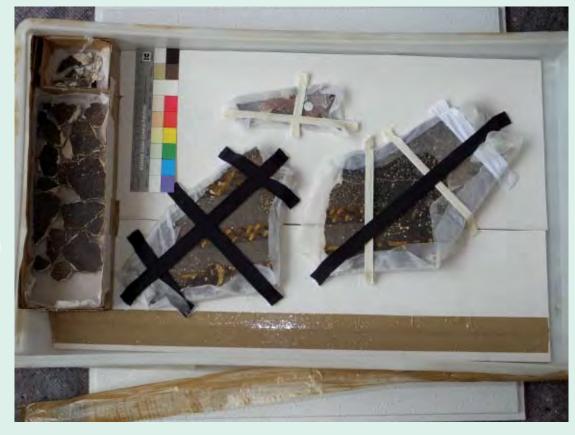
Fragments not removed from box as too fragile. Paint layer contains blue plain decoration with gilded decoration. Some bubbling of paint evident from fire damage.

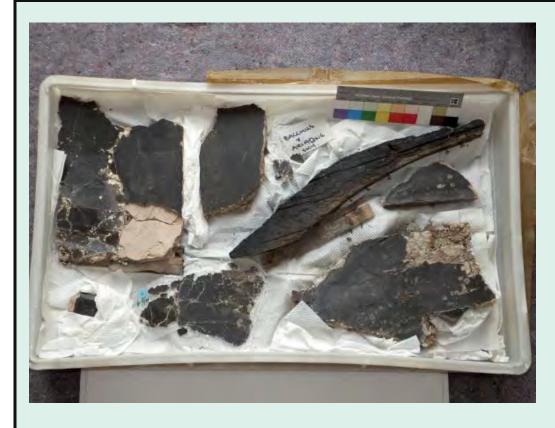
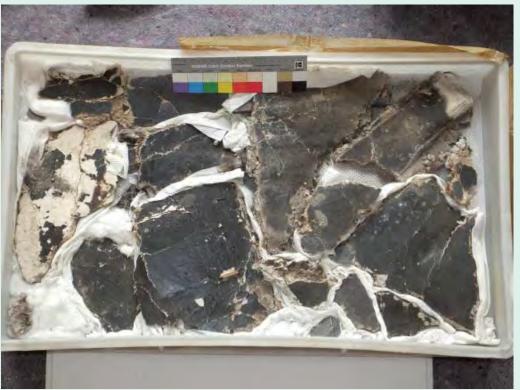
Fragments are all very badly charred by fire damage, and are generally in poor condition.

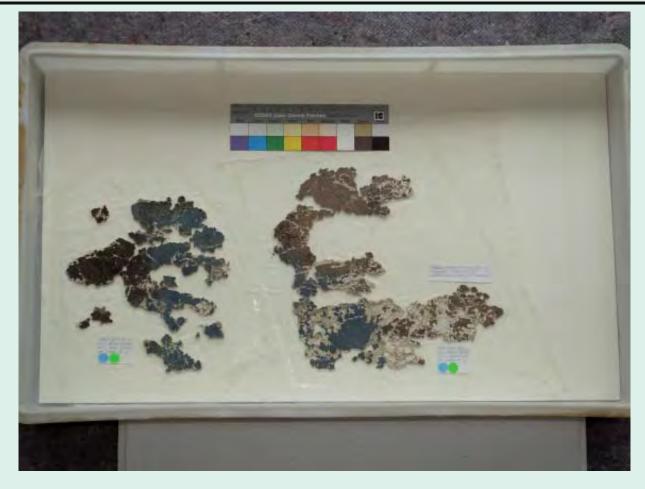
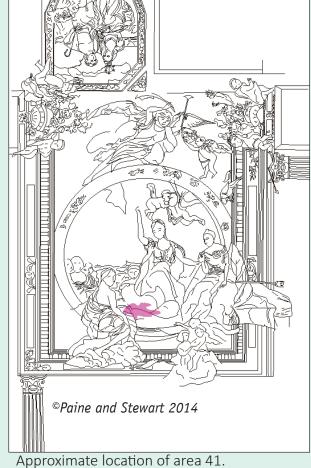
Fragments are all very badly charred by fire damage, and are generally in poor condition.

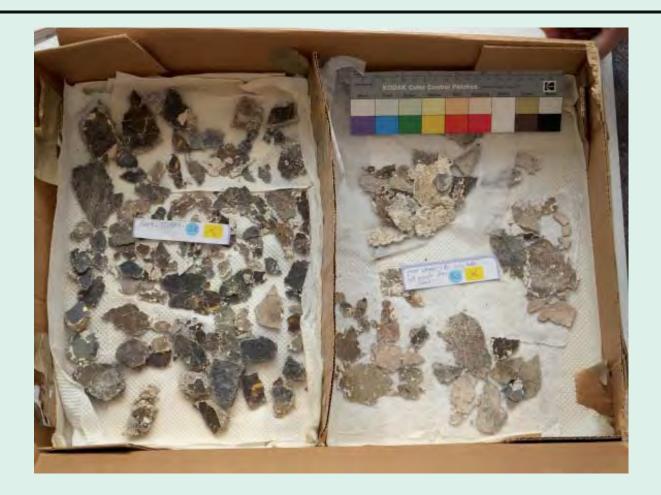
Multiple fragments, very damaged. No discernible subject matter evident.

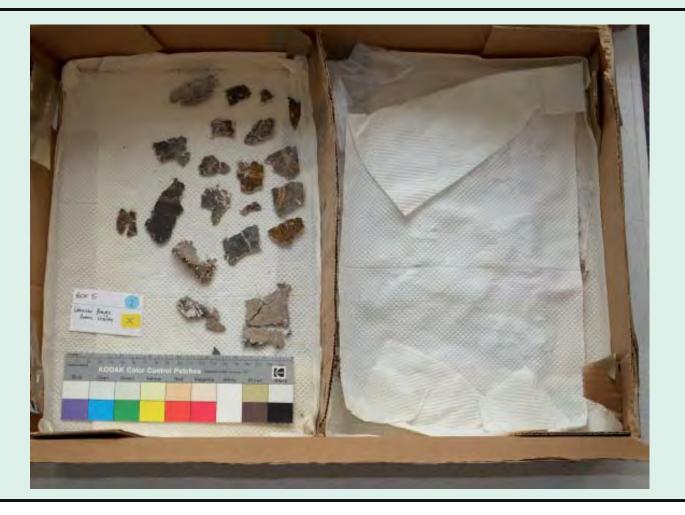
Multiple fragments, very damaged. No discernible subject matter evident.

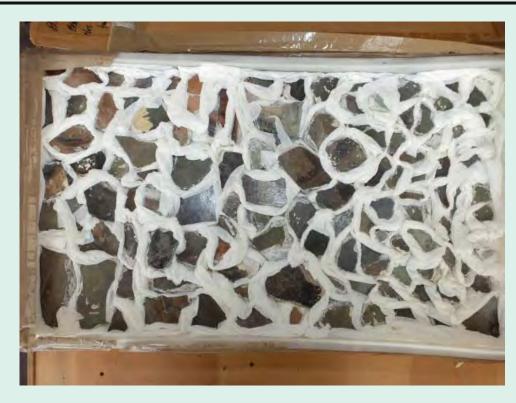
Multiple fragments. More coherent areas of paint layer are evident. Some areas have quite clearly been coated with a glossy material, presumably as part of a previous restoration.

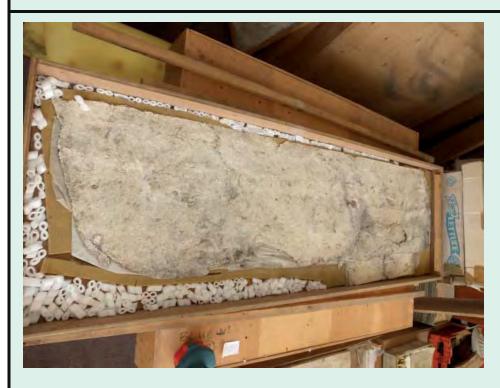
One large fragment, faced. Not turned over as very fragile. The back of the fragment has been reduced. The foam padding is mouldy and deteriorating.
