# Broomfield House: condition survey of the Lanscroon wall painting fragments ~ August 2014

#### 1 Introduction and summary of the report

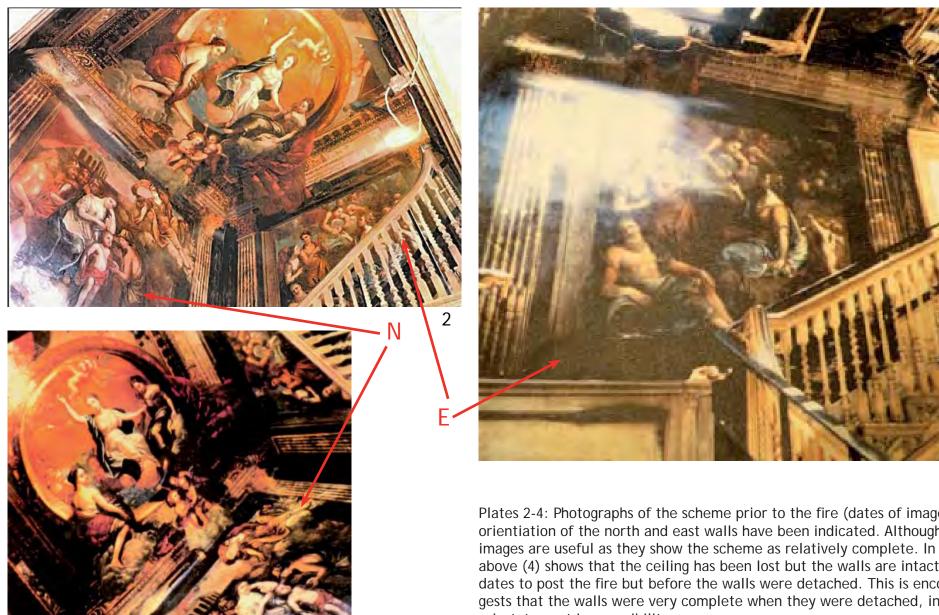
Also, a very interesting photograph survives (Plate 4) which that the ceiling has been lost but the walls are intact and so presumably dates to post the fire but before the walls were detached. This is encouraging as it suggests that the walls were very complete when they were detached, indicating that reinstatement is a possibility.

Plates 2-4: Photographs of the scheme prior to the fire (dates of images unknown). The orientiation of the north and east walls have been indicated. Although very low quality the images are useful as they show the scheme as relatively complete. In addition, the image above (4) shows that the ceiling has been lost but the walls are intact and so presumably dates to post the fire but before the walls were detached. This is encouraging as it suggests that the walls were very complete when they were detached, indicating that reinstatement is a possibility.

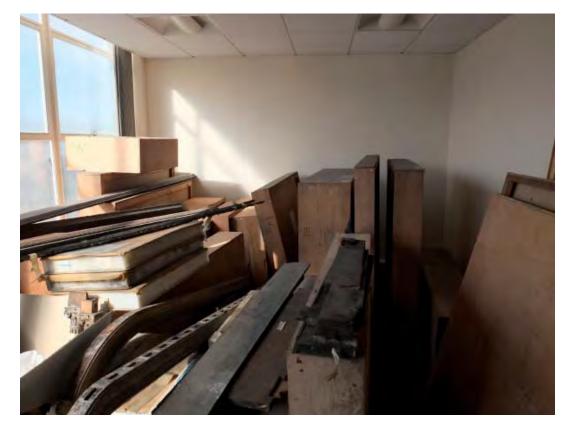
Plate 6 (below): The store also contains many elements of the original balustrade.

Plate 5 (above): The fragments are presently in store within wooden and card-board boxes.

Although many of the fragments are very fragile despite extensive conservation treatment in the 1980s, if properly stored the fragments should remain in a stable condition over the longer term. Great care was originally taken to protect all the fragments as far as possible but inevitably some packing materials are now failing and attention is now necessary to update the overall storage of the fragments. This would involve certainly for the smaller fragments usually associated with the ceiling, re-packing in new boxes with acid-free tissue and the removal of the polystyrene chips. For the larger fragments associated with the walls and coving which are usually stored in dedicated and purpose designed wooden boxes, these should be inspected to ensure they are adequate but retained where possible.

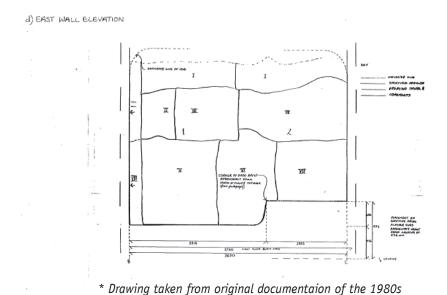
Figure 2: There are six extant fragments from the east wall elevation, as recorded on previous documentation above (author unknown). However, the paint layer is obscured by heavy facing layers.

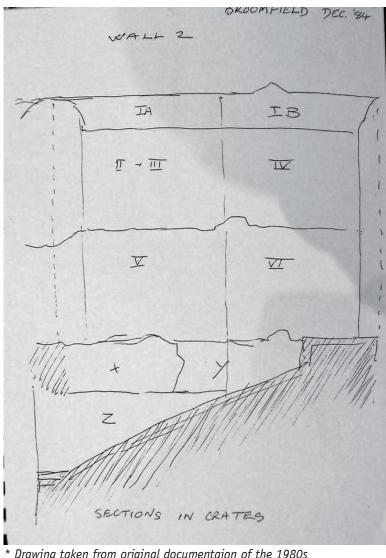
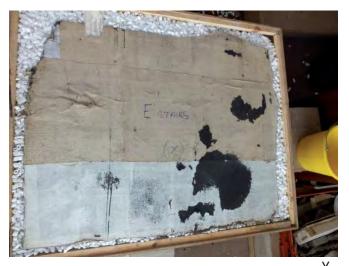
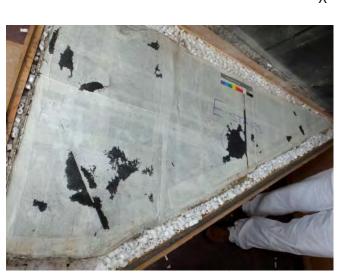
Figure 3: There are three further extant fragments from the east wall elevation, as recorded on previous documentation (author unknown). However, the paint layer is obscured by heavy facing layers.

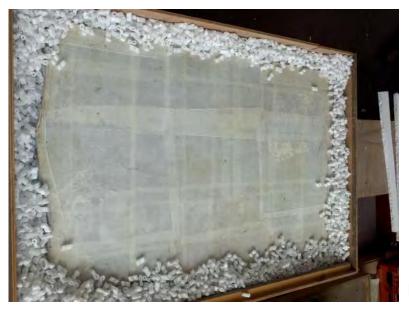
Figure 4: Two large fragments are recorded as belong to an area on the south wall landing (documented as Wall 4 Bacchus and Ariadne in previous documentation).

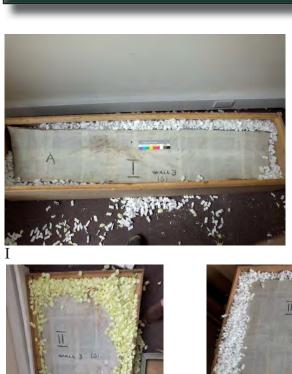
Figure 6: There are eight extant fragments from the southwall elevation, as recorded on previous documentation below (author unknown). However, the paint layer is obscured by heavy facing layers.

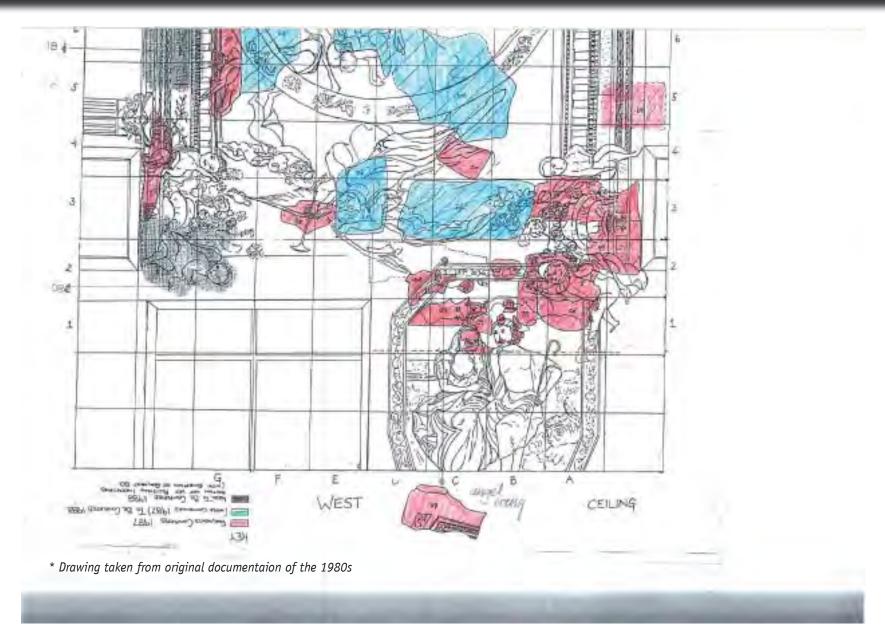
Figure 7: Copy of the previous documentation of the ceiling found with the fragments, which colour codes fragments already treated by 1987 and to be completed by 1988. This clearly shows the fragmentary nature of the surviving remains of the ceiling.

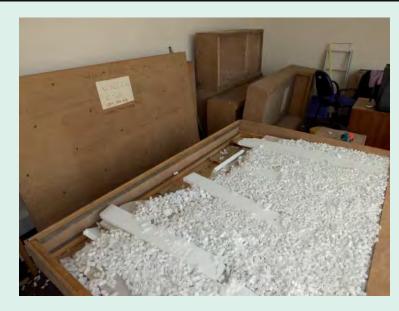
One large fragment (180cm x 138cm). The fragment has been faced with various types of gauze with different weaves. The paint layer appears to be in good condition beneath.

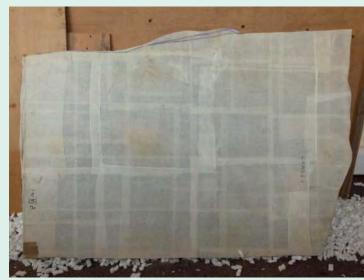
One large fragment (94cm x 137cm). The fragment has been faced with gauze. The paint layer appears to be in good condition beneath.

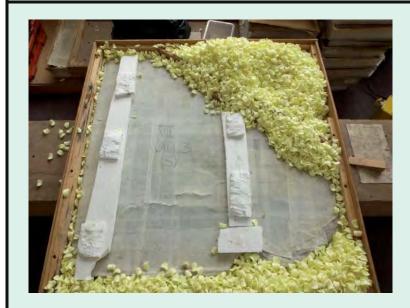
Dimensions 110cm x 110cm. Polystyrene glued to facing as part of protection. Fragment heavily faced so the paint layer is not visible.

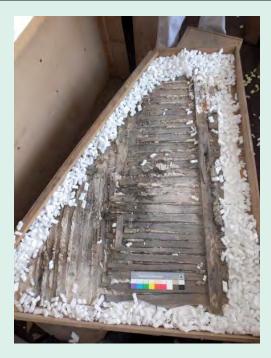
Large fragment (87x150x117cm), faced with gauze and canvas.

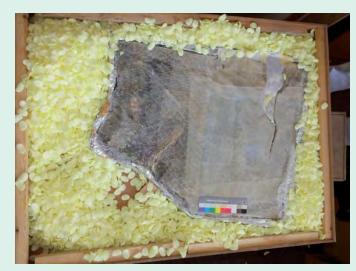
Large fragment (80x65cm). Facing has trappoed the paint film- facing different and brittle. Probably poor choice of adhesive; whole fragment mounted on a tin-foil lined support.

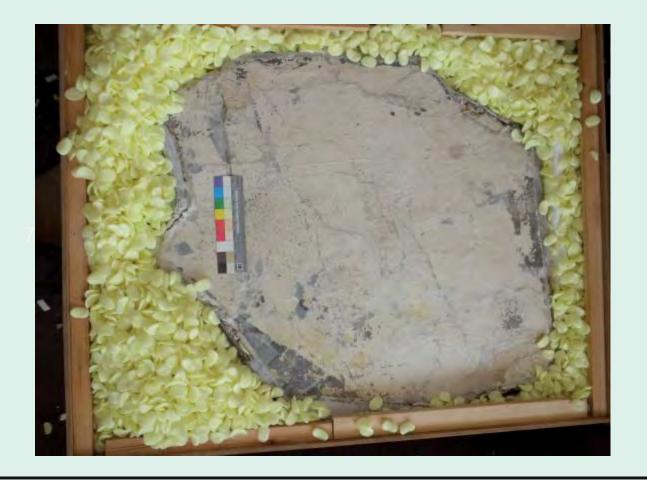
Large fragment (75x80). Note describes: 'C5/D5/D6; 17/8/84 C; Bare plaster, cleaning and fixing skim layer to plaster/hair, using PVA 6815 (?). Skim plaster fixed in place using Vinamul 6815 full strength after wetting with 50:50 IMS: water. Skim plaster attached to facing removed and replaced. Some distortion was noted. Vinamul 6815 was also used. The skim was temporarily protected with a facing of nappy liner and Tenax 50:50 in water.'

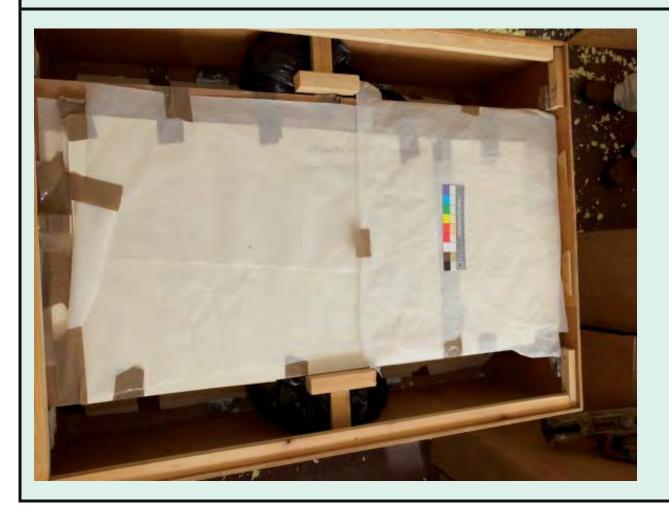
Large fragments. Very little description but one note describes: '(76) Coving blue 8-9H One piece of fragment. Stored on Coving shape box- has been thinned'.

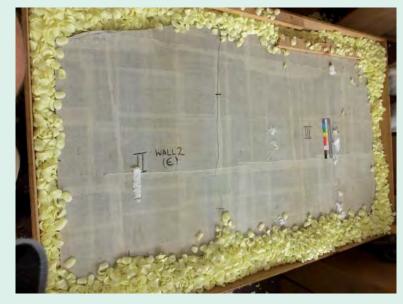
Large fragment. Faced with tissue. Extensive remains of paint layer evident.

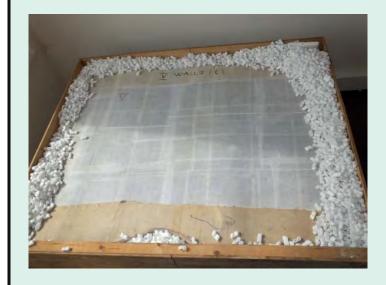
Large fragment. Different types of facing. Extensive remains of paint layer evident.

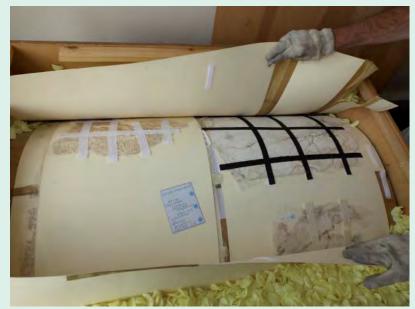
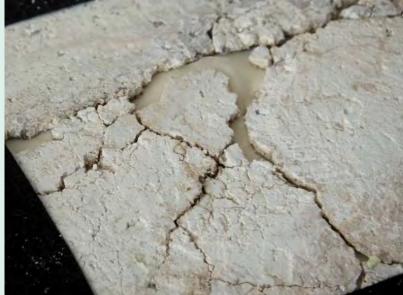
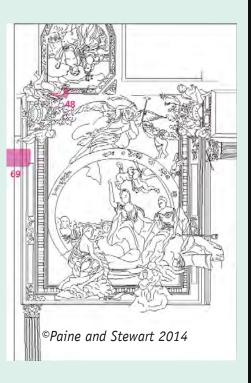
Fragments very fragile so not removed for inspection. Fragments 48 and 71 have the following descriptions: '48 Coving Blue Box D1. Above Bacchus and Ariadne. Piece of coving above putti. Just one piece of fragment stored on coving shape box- has been thinned.' '71 Known as A/4. Part of coving- position not identified. Treatment: back has been reduced to skim plaster. Facing is crepeline and Beva 37 40:60 in white spirit. Note: Fragments belonging to this piece are boxed separately'.

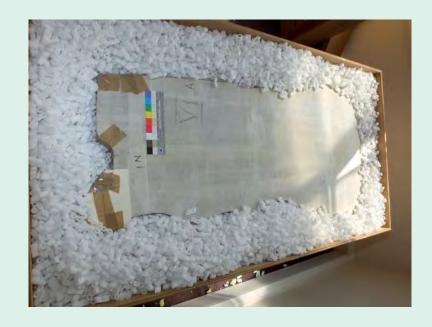
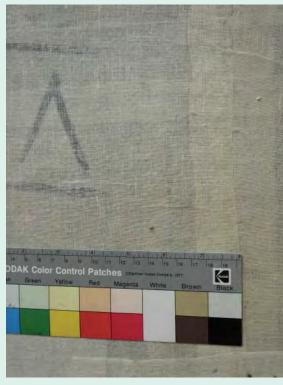
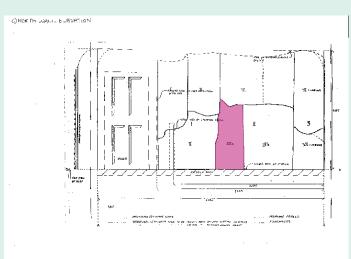
Dimensions: 130mm x 70mm. Fragment heavily faced with gauze. Difficult to ascertain condition but the paint layer appears intact below with some loss/repair.

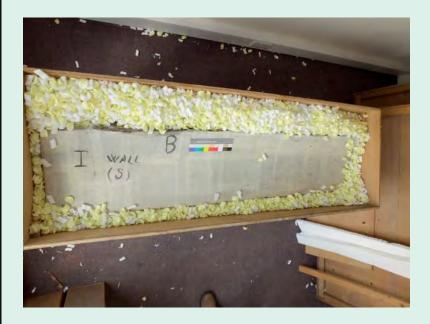
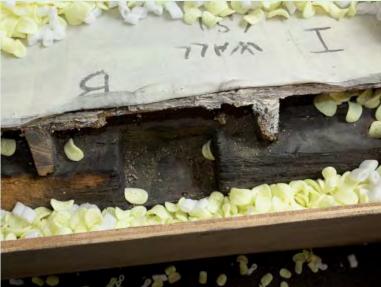
Dimensions: 160mm x 40mm. Fragment heavily faced with gauze. Difficult to ascertain condition but the paint layer appears intact below with some loss/repair.

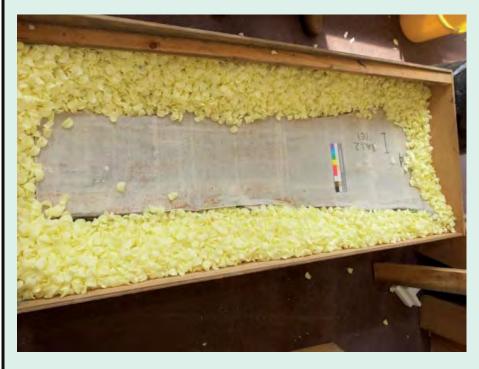
Dimensions: 50mm x 150mm. Fragment heavily faced with gauze. Difficult to ascertain condition but the paint layer appears intact below with some loss/repair.

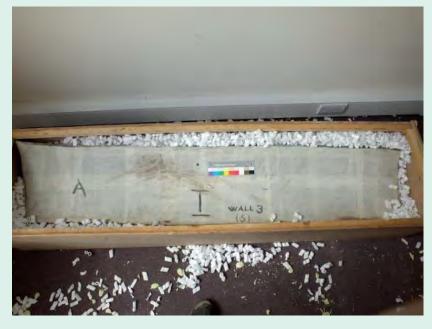
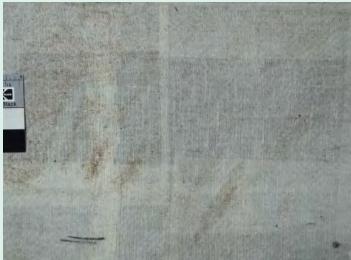
Dimensions: 165mm x 35mm. Fragment heavily faced with gauze. Difficult to ascertain condition but the paint layer appears intact below with some loss/repair.

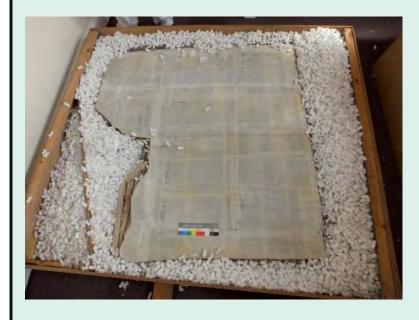
Dimensions: 120mm x 140mm. Fragment heavily faced with gauze. Difficult to ascertain condition but the paint layer appears intact below with some loss/repair.

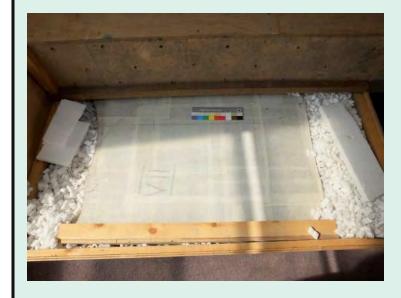
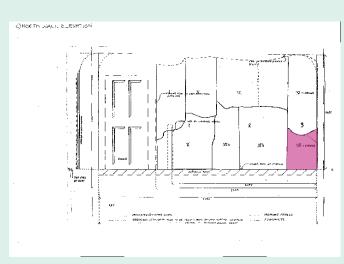
Fragment heavily faced with gauze. Difficult to ascertain condition but the paint layer appears intact below with some loss/repair.

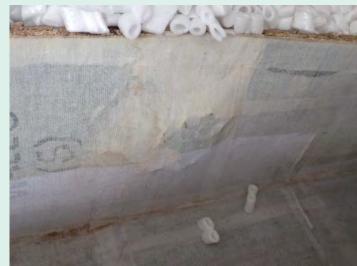
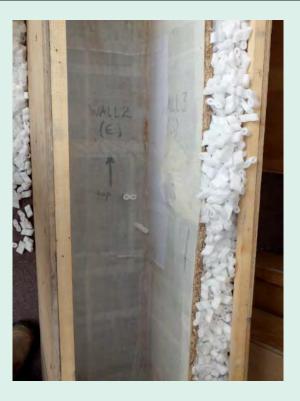
Dimensions 250mm x20 x20: Fragment heavily faced with gauze. Difficult to ascertain condition but the paint layer appears intact below with some loss/repair. One area clearly fractured.

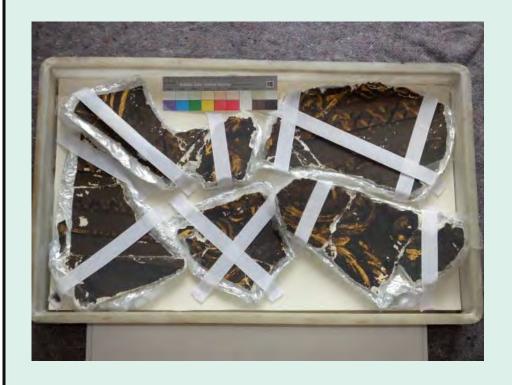
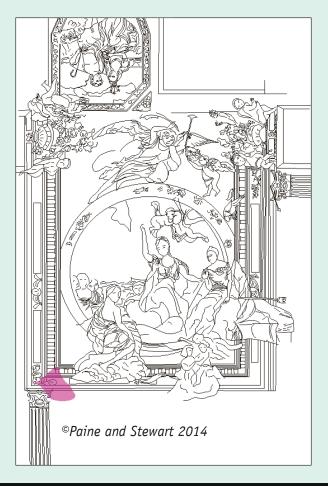
Approximate location of area 75.

Gauze backing. Area is part of fictive architectural framework, and shows a dark brown background with elements picked out in gold and black paint.

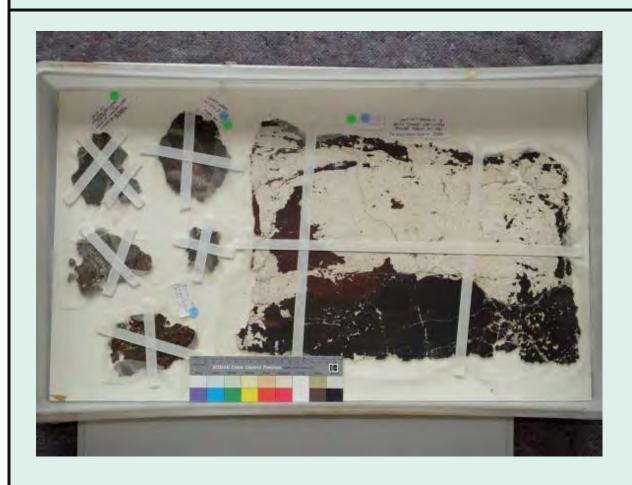
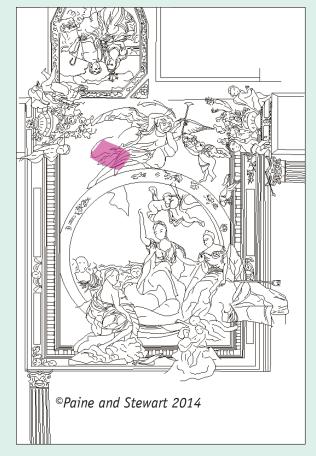
Approximate location of area 42.

Gauze backing.

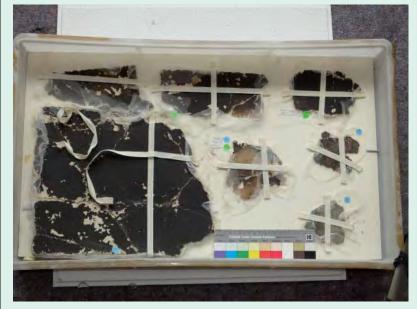
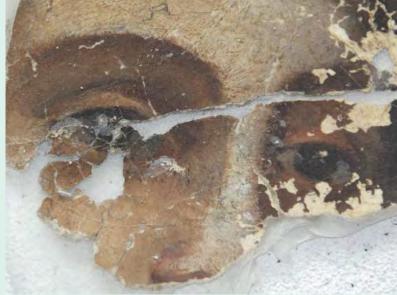
Approximate location of area 56 (eyes of Ariadne).

Gauze backing.

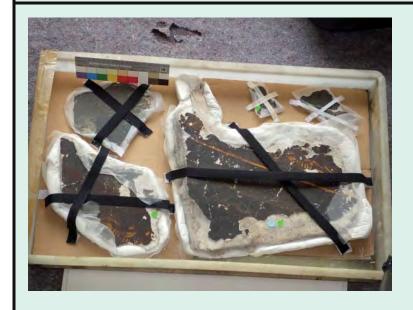
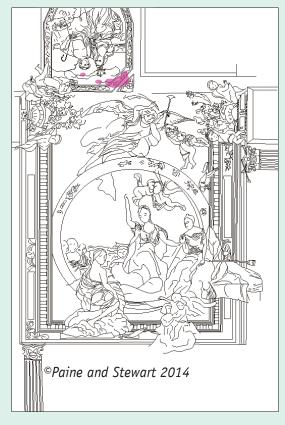
Approximate location of areas 44 and 59.

Fragments not removed from box as too fragile. Labels describe Area 35(3) and Bacchus and Ariadne 46(4). It is not clear which area fragments 1, 2 and 5 belong to.

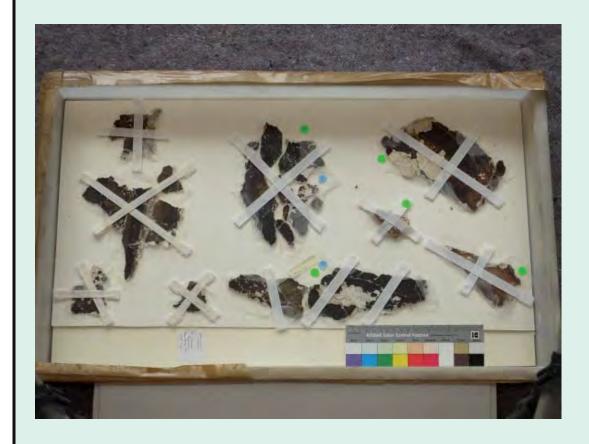
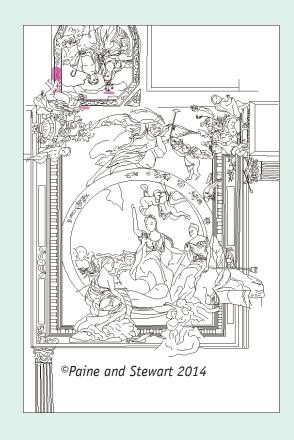
Fragments not removed from box as too fragile. Labels describe Area 35(3) and Bacchus and Ariadne 46(4).

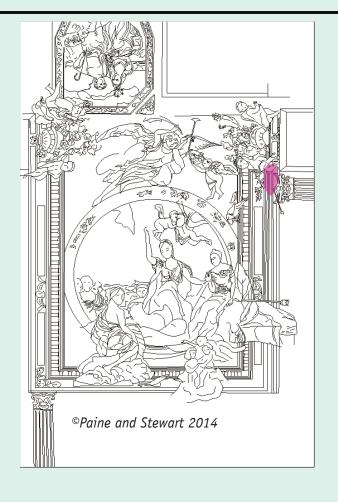
63(1&2); 50(3)

Fragments not removed from box as too fragile. Paint layer contains blue plain decoration with gilded decoration. Some bubbling of paint evident from fire damage.

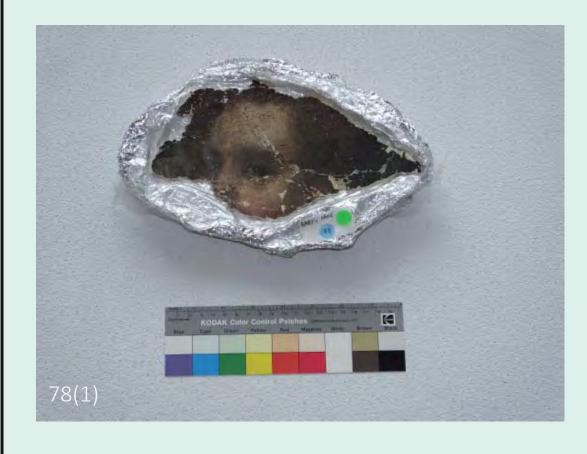
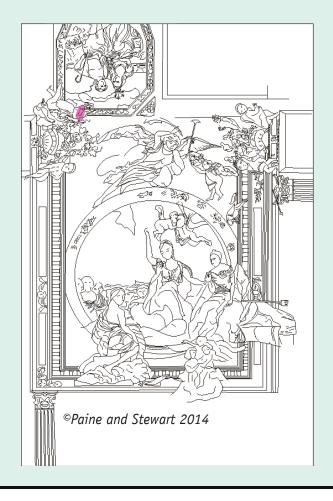
Pale fine plaster render with plaster skim (1-2mm); render contains some hair (fragment too fragile to take reverse photograph).

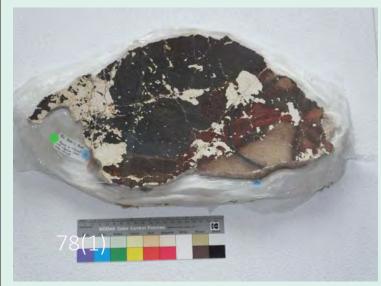
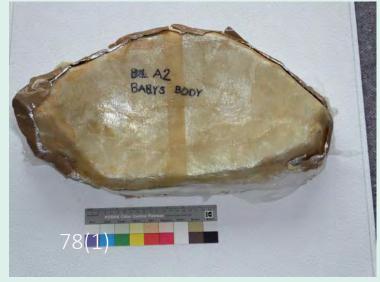
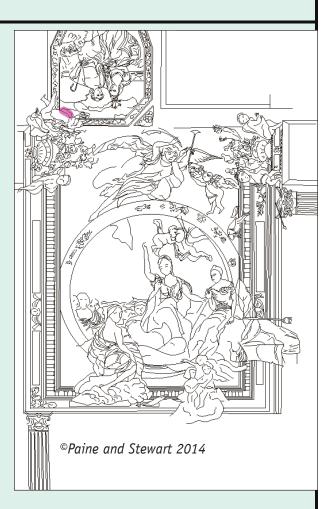
Pale fine plaster render with plaster skim (1-2mm); render contains some hair (fragment too fragile to take reverse photograph).

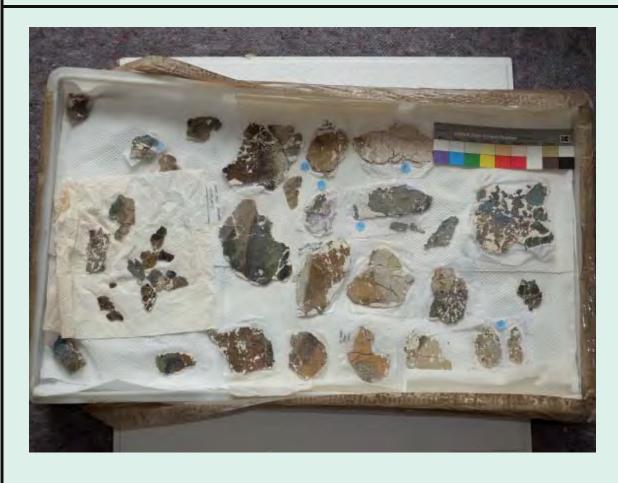
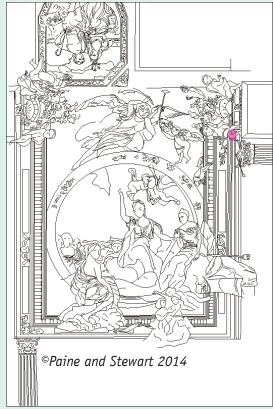
Approximate location of area 65 but other locations not established.

Fragments contain extensive remains of paint layer.

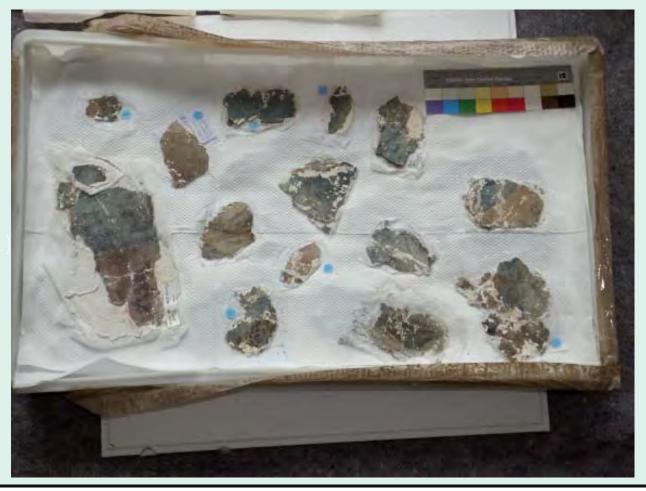
Approximate location of area 65 but other locations not established.

Fragments contain extensive remains of paint layer.

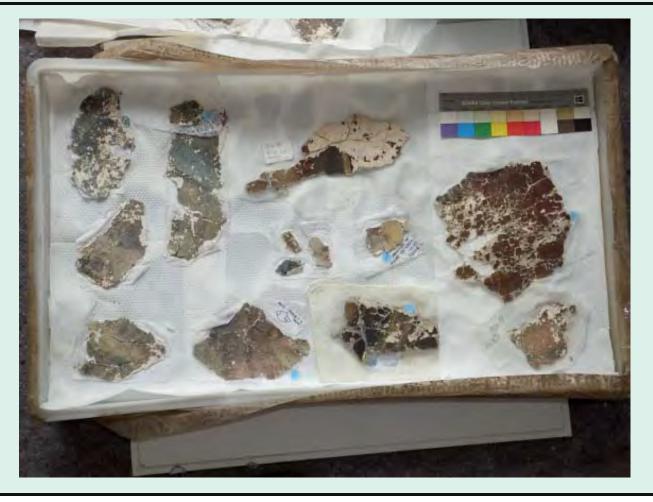
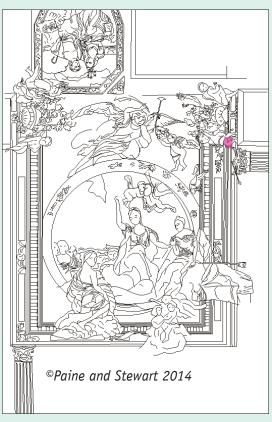
48

Fragments contain extensive remains of paint layer.

Approximate location of area 65 but other locations not established.

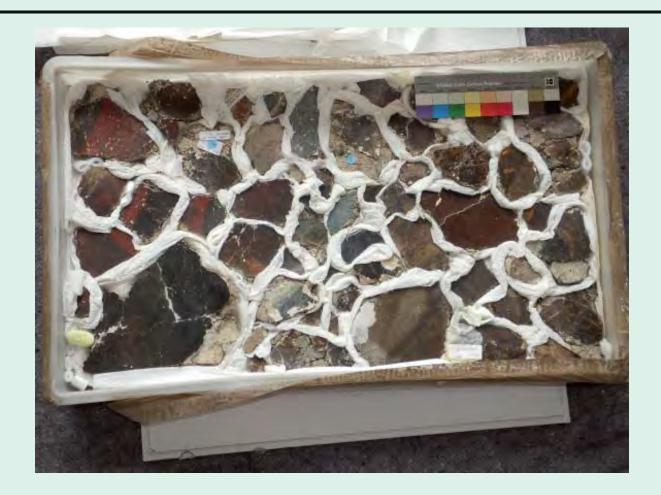
Fragments contain extensive remains of paint layer- blue and dark red.

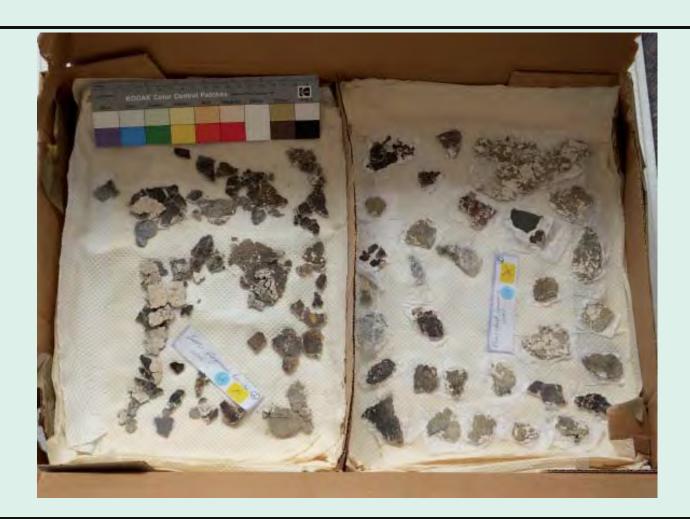
Multiple fragments, some faced. No discernible subject matter evident.

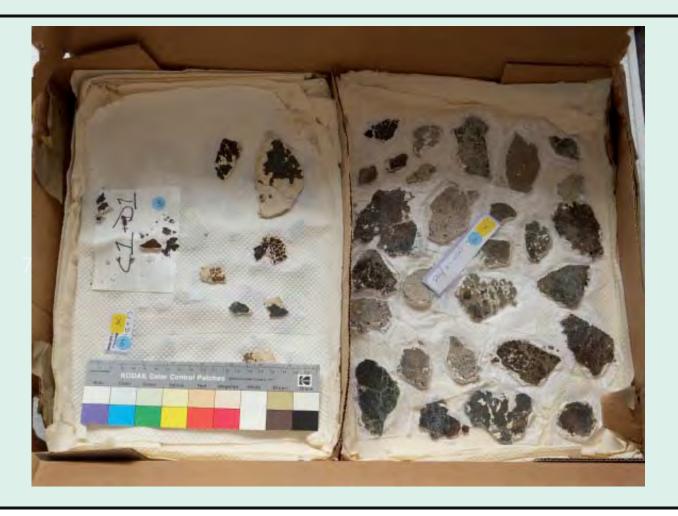
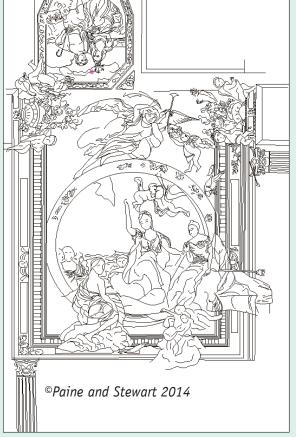
Multiple fragments, some faced. No discernible subject matter evident. Some fragments set in plaster of Paris.

Approximate location of area 60.

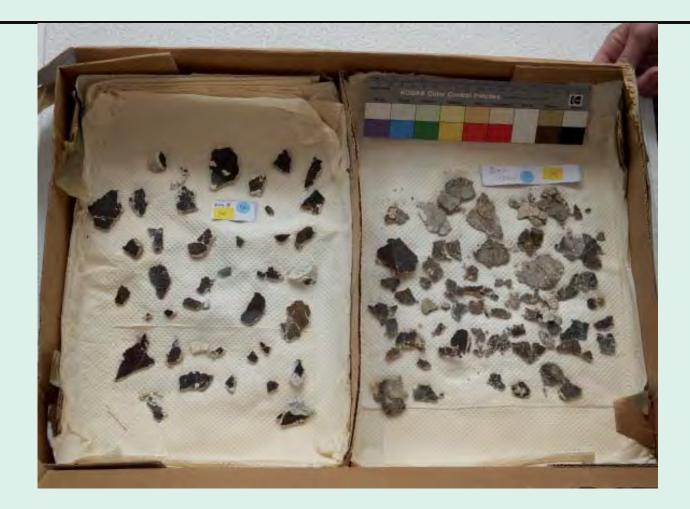
Multiple fragments, some faced. No discernible subject matter evident. No facing or repairs undertaken.

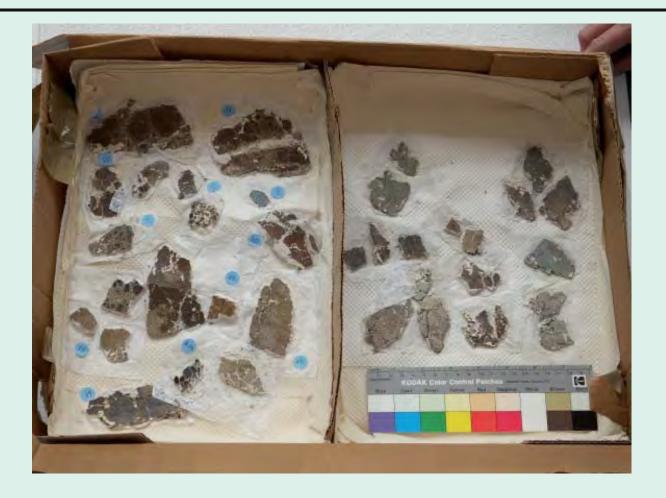
Multiple fragments, some faced. No discernible subject matter evident. Some plaster of Paris repairs.

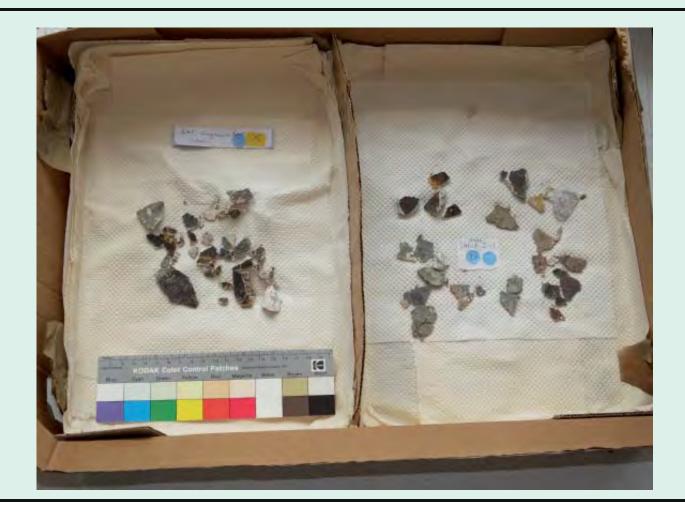
Multiple fragments, some faced. No discernible subject matter evident.

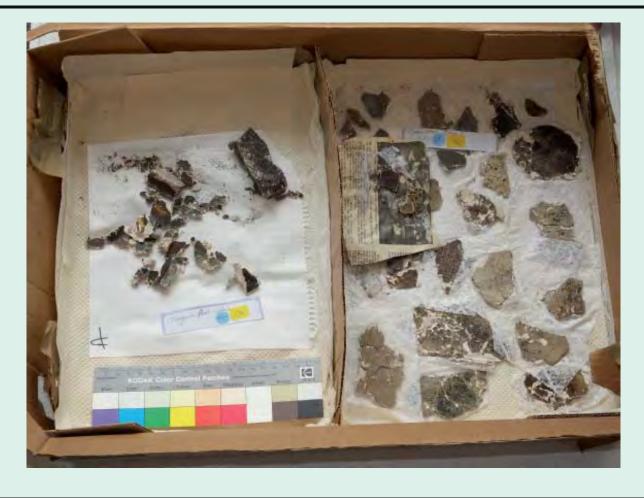
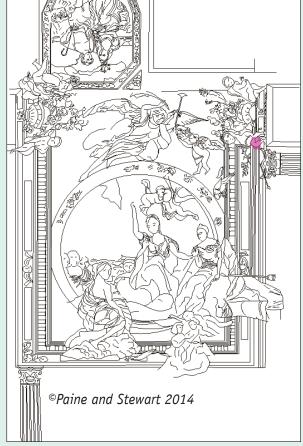
Multiple fragments, some faced. No discernible subject matter evident.

Approximate location of area 65.

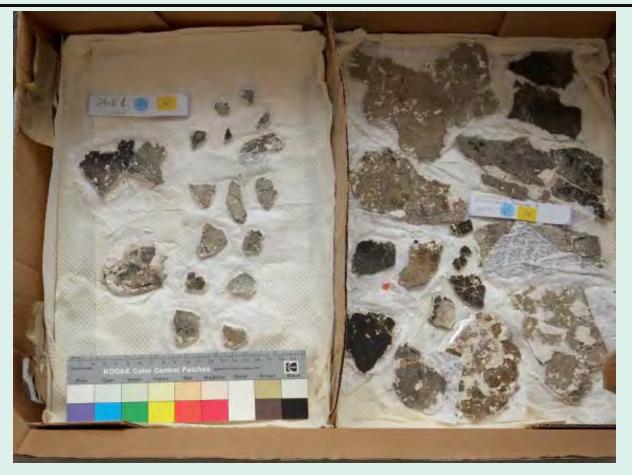
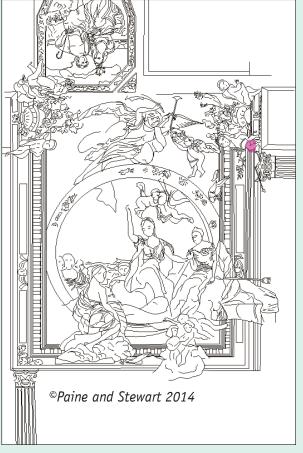
Multiple fragments, some faced. No discernible subject matter evident. Some fragments set in plaster of Paris.

Approximate location of area 65.

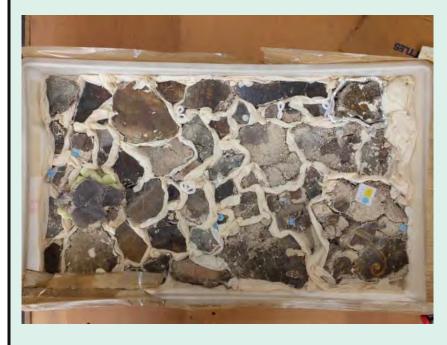
Multiple fragments. More coherent areas of paint layer are evident; one fragment shows the top of a fictive capital, painted in gold.

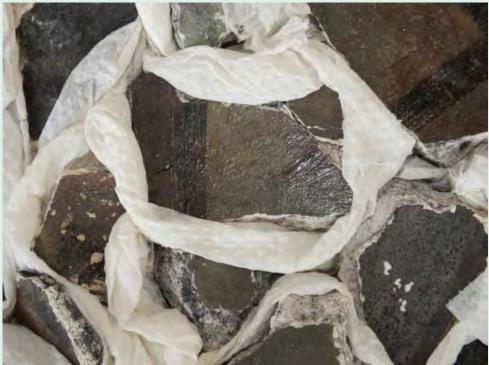
Multiple fragments. More coherent areas of paint layer are evident. Some areas have quite clearly been coated with a glossy material, presumably as part of a previous restoration.

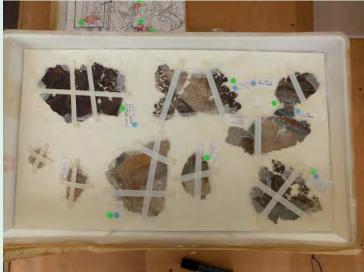
Multiple fragments from the ceiling. More coherent areas of paint layer are evident, including a very fine face of a female figure.

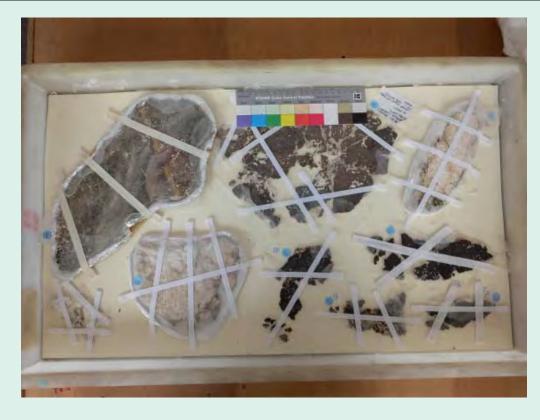
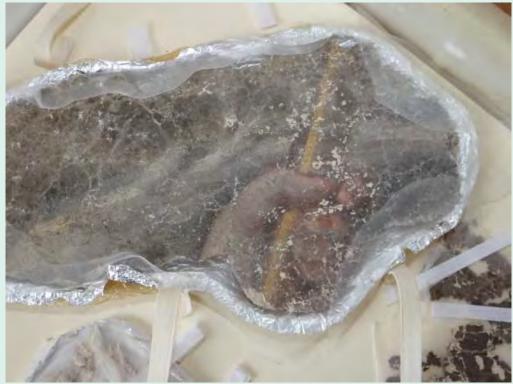
Multiple fragments. More coherent areas of paint layer are evident, including a fragment holding a staff(?).

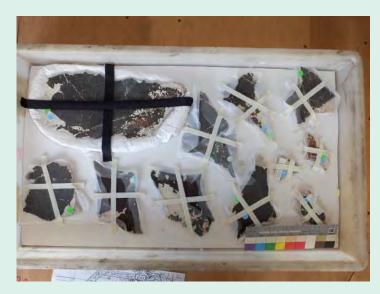
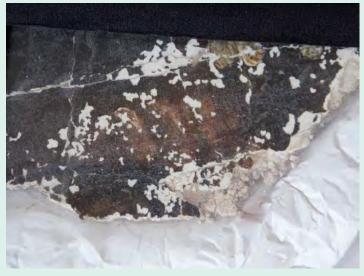
Multiple fragments. More coherent areas of paint layer are evident. Fragments faced with muslin.

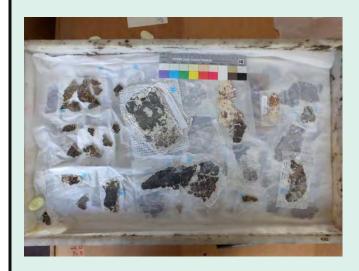
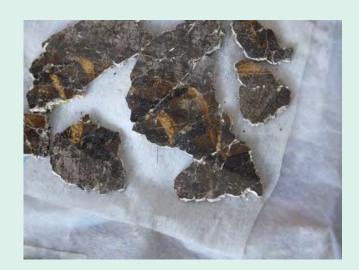
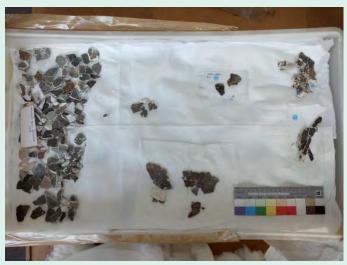
Multiple fragments. More coherent areas of paint layer are evident. Fragments faced with muslin.

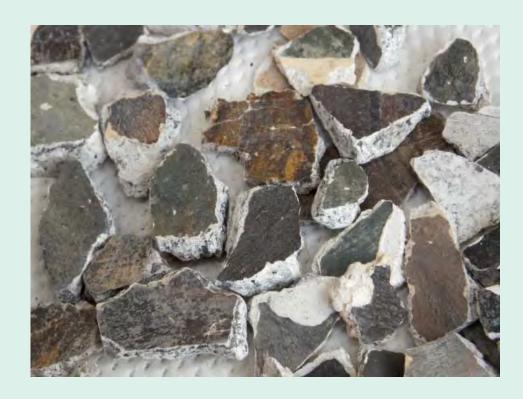
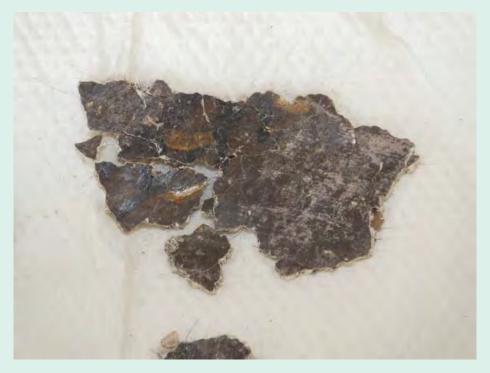
Multiple fragments. More coherent areas of paint layer are evident.

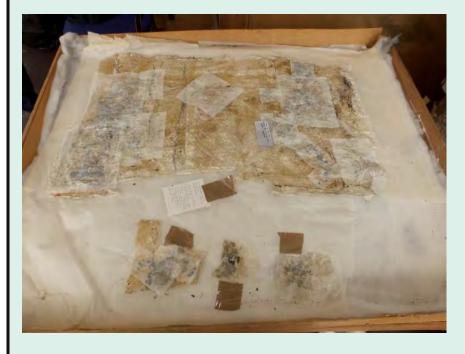
Fragments of facing paper presumably used during the detachment of areas- the sheets have been retained as many have substantial areas of paint layer still adhering to the underside.

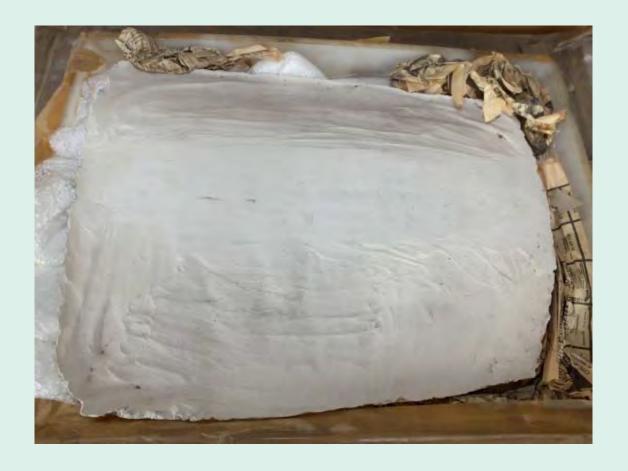
No painting. Plaster supports, dated from the packing newspaper as 1987.

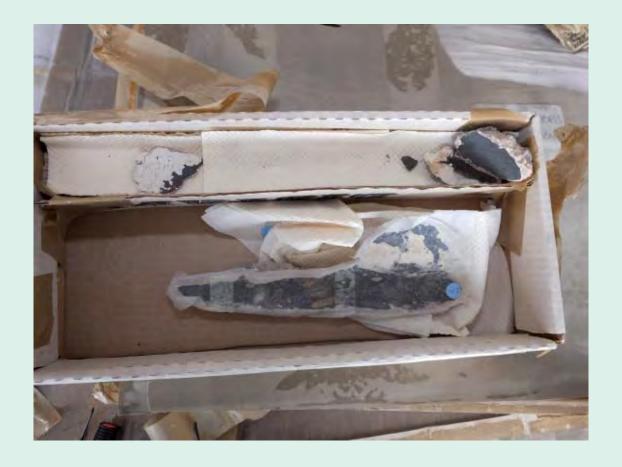
Multiple fragments. More coherent areas of paint layer are evident.

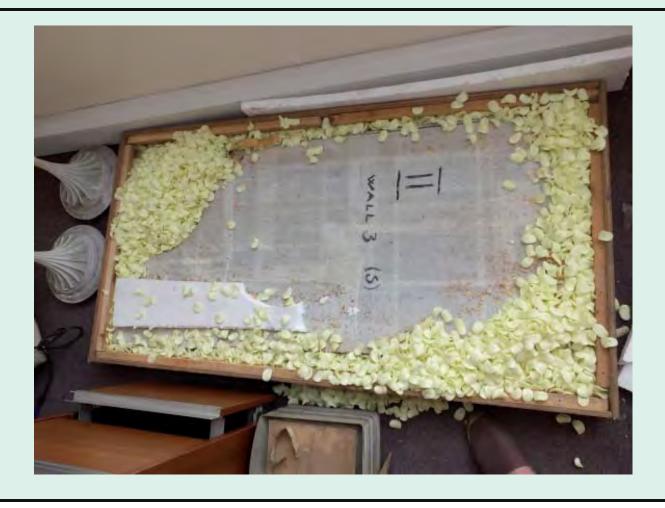
One large fragment, faced. Not turned over as very fragile.
